DECLARATION OF DAVID J. ERICKSON

David J. Erickson
President and Hydrogeologist
Water & Environmental Technologies,
PC

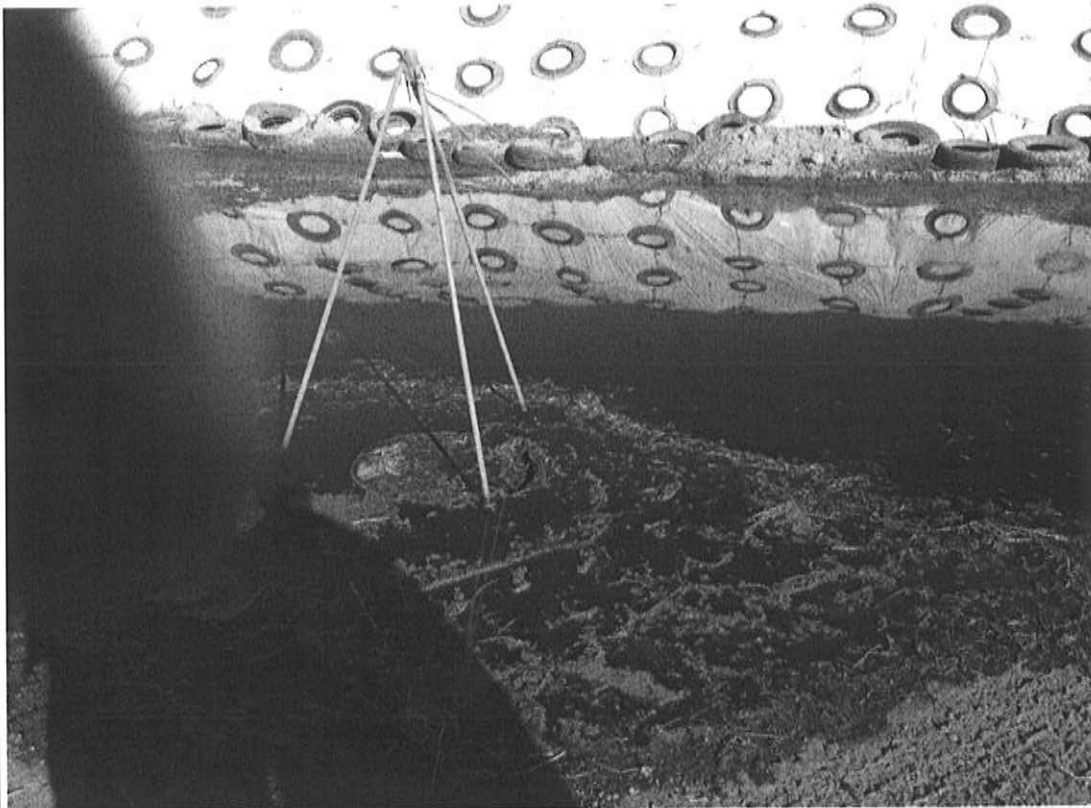
Photo: View during October 2013 inspection of drop inlet near Safety Debris Basin collecting silage leachate. Leachate was being conveyed through a pipe and discharged into Safety Debris Basin.

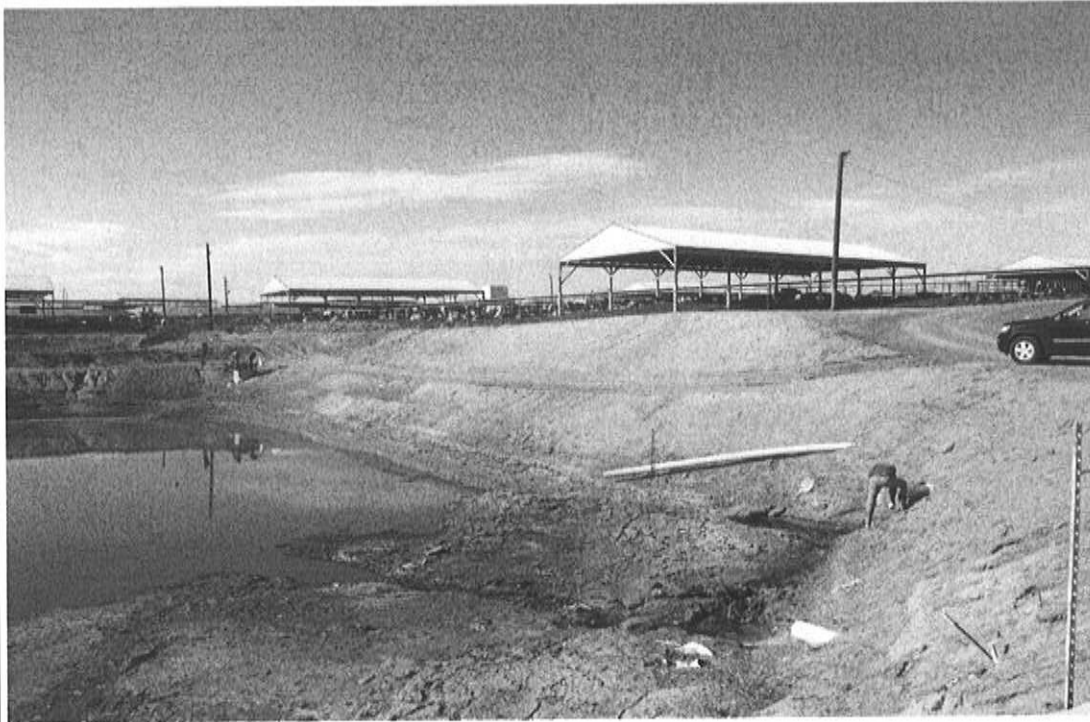
Photo: View during October 2013 inspection of Safety Debris Basin. A sample of silage leachate being discharged into the basin is being collected at right.

1 sampling accomplished by Plaintiffs during their October 2013 and May
2 2014 site visits of Cow Palace Dairy. During the 2013 visit, I oversaw the
3 collection of a sample of silage leachate that was being collected from the
4 base of a silage pile into a drop inlet with a grated manhole cover, conveyed
5 in a buried pipe, and discharged into the Basin. The sample contained
6 nitrate at a concentration of 29.5 ppm, ammonia at 574 ppm, and a total
7 nitrogen content of 2,850 ppm. Erosion can occur at pipe discharge
8 locations, especially when liquid falls some distance from the end of the pipe
9 to the discharge point (as depicted in the photographs above), and would
10 likely compromise any manure seal that would otherwise be present in the
11 basin.

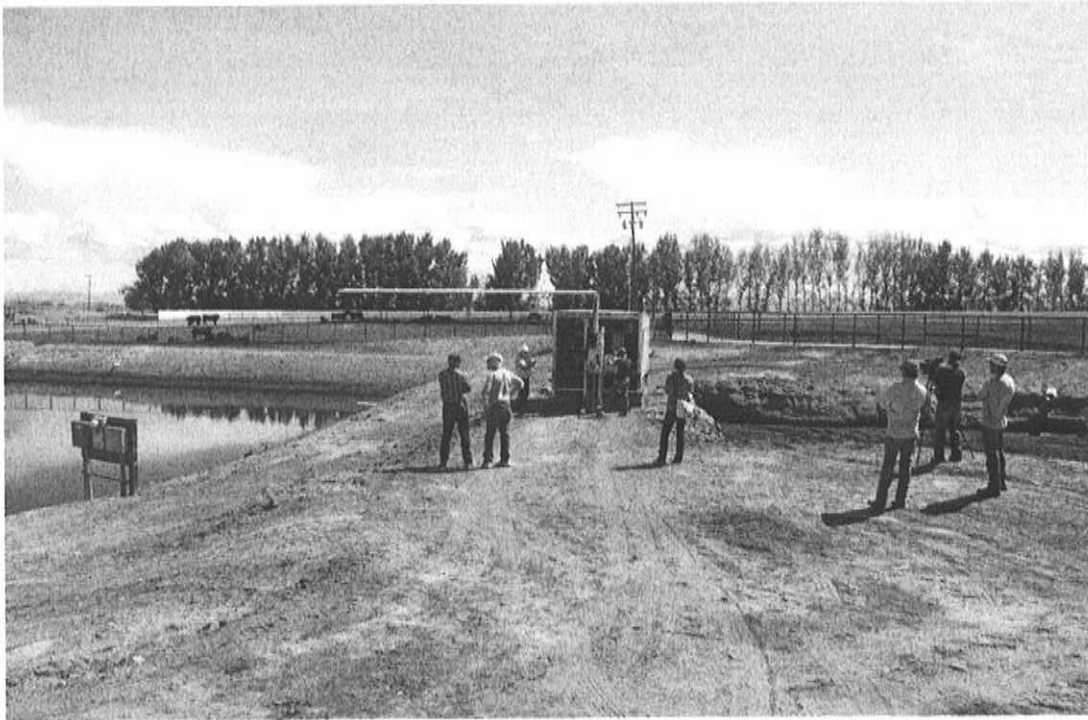
Photo: View to south during May 2014 inspection. Safety Debris Basin visible at left and storm water catch basin at right.

54. There is no question that Safety Debris Basin and the adjacent stormwater catch basin discharge liquid into the ground.

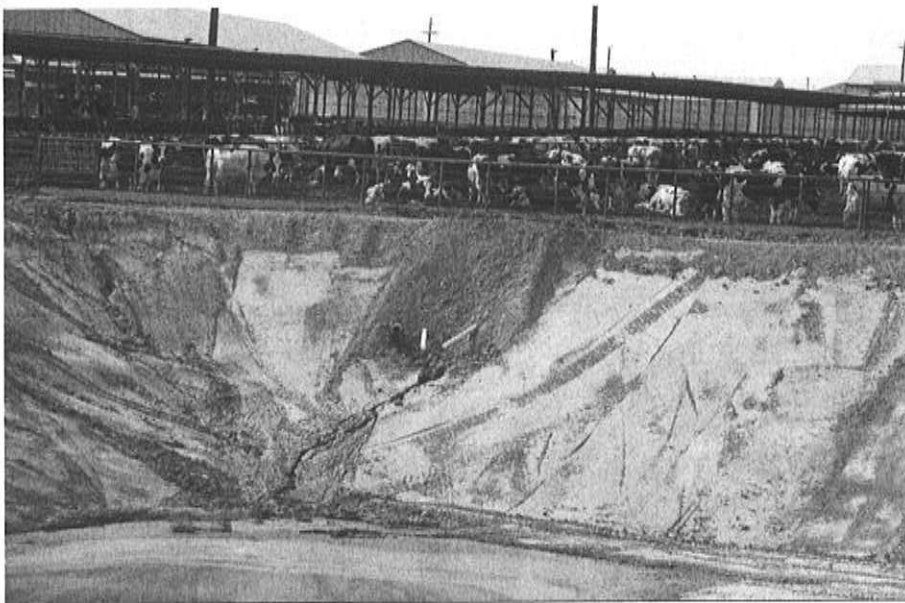
9 Photo. View of NW Catchment Basin during October site visit. New liner
10 with significant erosion from infall pipes is shown.

2 63. The photos above represent the condition of the Catch Basin NW as it
3 was at the time of Plaintiffs' October 2013 inspection. As is evident from
4 the photographs, Cow Palace had recently completed re-sloping the sides
5 and compacting the soil liner.

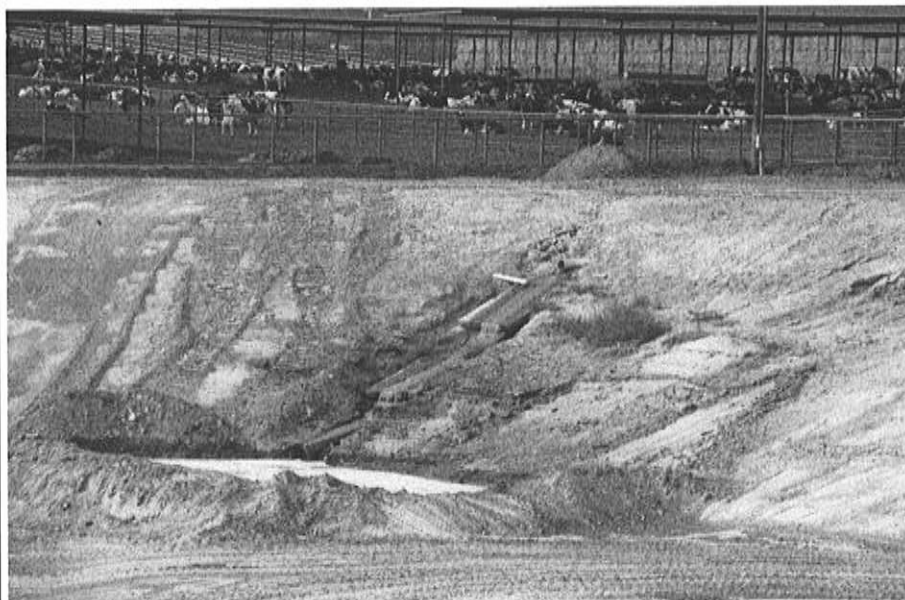
20 Photo. View of NW Catchment Basin. Outfall from calf pens with liquid

1 infiltrating is shown.

6 64. There is no question that the Catch Basin NW discharges liquid waste
7 and manure into the ground, especially considering that operation of an air
8 rotary drill 50 feet away provided sufficient air pressure to penetrate the
9 liner of the impoundment, even at 35% capacity. Assuming that the Lagoon
10 has a soil liner that is one foot thick and contains liquid during at least six
11 month per year, the Basin leaks between 831 and 8,314 gallons of manure
12 per day, or between 160,000 and 1.6 million gallons/year depending on the
13 specific permeability of the soil. Given, however, that the soil types in the
14 area are of moderate to high permeability, and that Cow Palace has not
15 maintained its manure seal properly, the specific discharge amounts are
16 likely on the high end of my calculations.

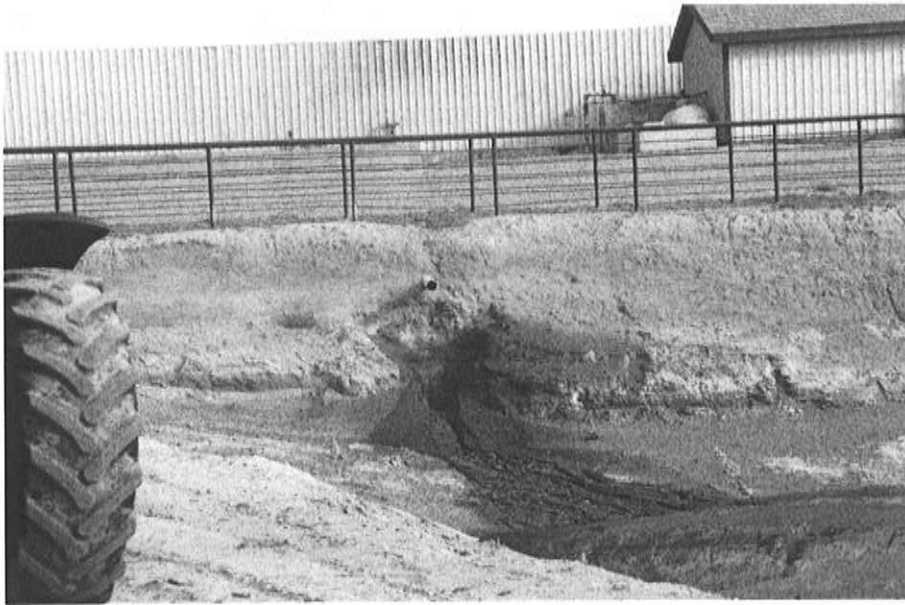
Photo. View of NE Catchment Basin. Note erosion from inflow and lack of manure seal.

69. Based on observations, this basin contains liquid during most of the year. Assuming the basin has 4 feet of liquid, and the manure seal provides a one order of magnitude seal, the following table summarizes the suspected leakage from the basin.

There is no question that the Catch Basin NE discharges liquid manure and

1 other liquid wastes into the ground. Even assuming that the lagoon has a soil
 2 liner that is one foot thick, and a liner permeability of 1×10^{-7} cm/sec while
 3 maintaining the lagoon under half-full conditions, the Catch Basin NE leaks
 4 193 gallons per day, assuming that the pond is half-full at least 4 months of
 5 the year. Given, however, that the soil types in the area are of moderate to
 6 high permeability, and that Cow Palace has not maintained its manure seal
 7 properly, I believe that the specific discharge amounts are likely on the high
 8 end of my calculations.

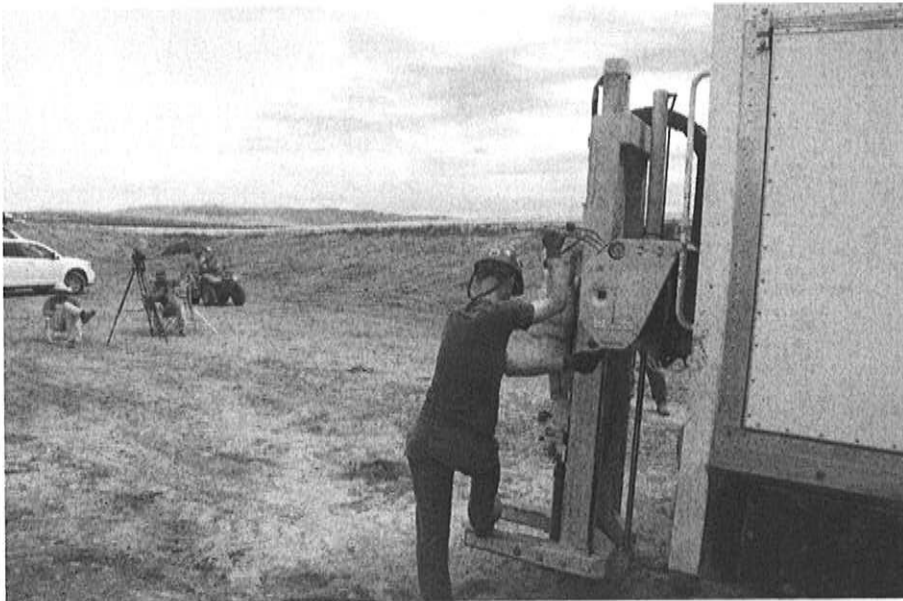
15 Photo. Collecting Geoprobe samples in the Bottom of Haak Lagoon.

16 77. On May 23, 2014, I supervised the use of the Geoprobe hydraulic drill
17 within Haak Dairy's large manure storage lagoon, which had been
18 previously emptied some 7 months earlier in October 2013; mechanically
19 excavated and scraped in November, 2013, which removed any type of
20 "manure seal" that would have been present, and any other remaining solid

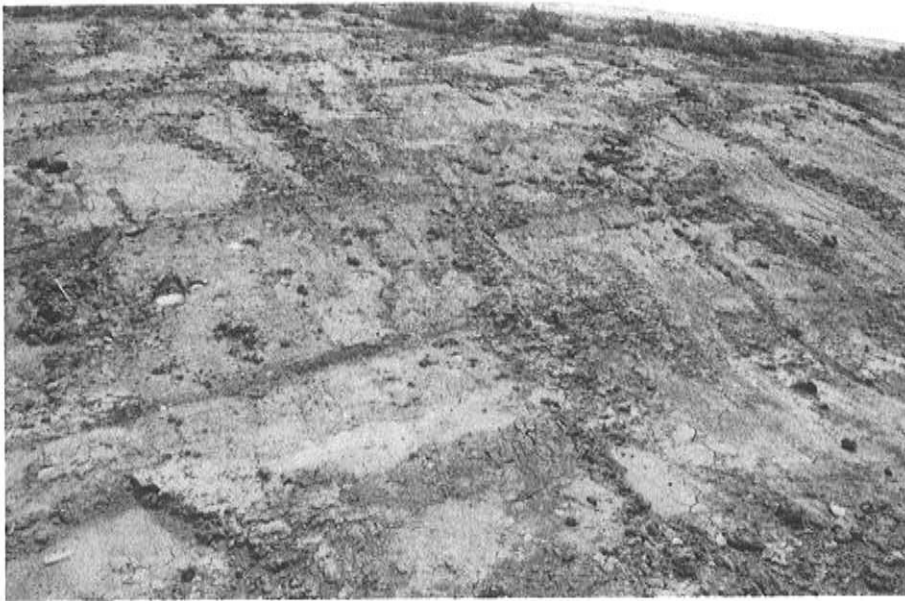
9 Photo: Side of Haak Lagoon with manure cake and native soil exposed.
10 Note gravel and cobbles.

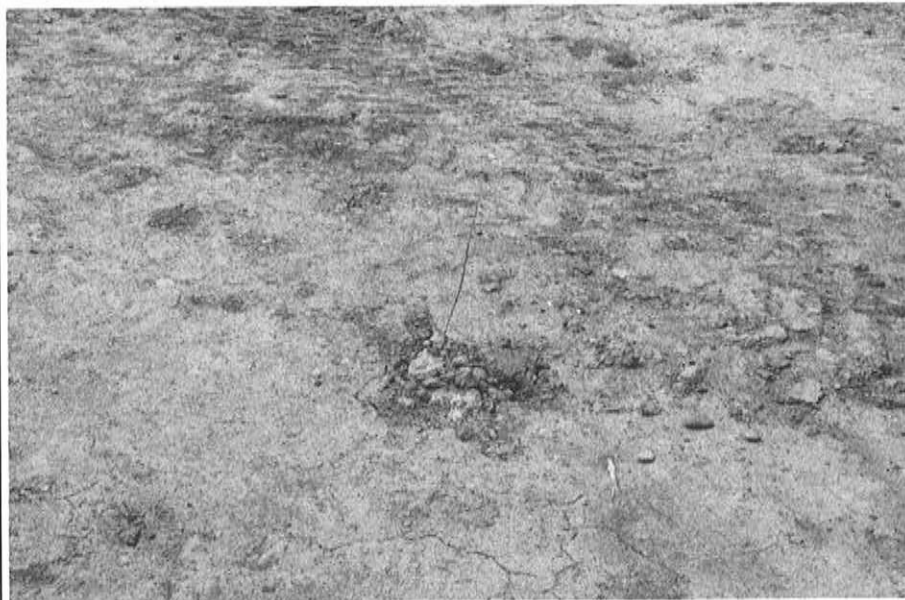
18 Photo. Bottom of Haak lagoon with native soil and wire.

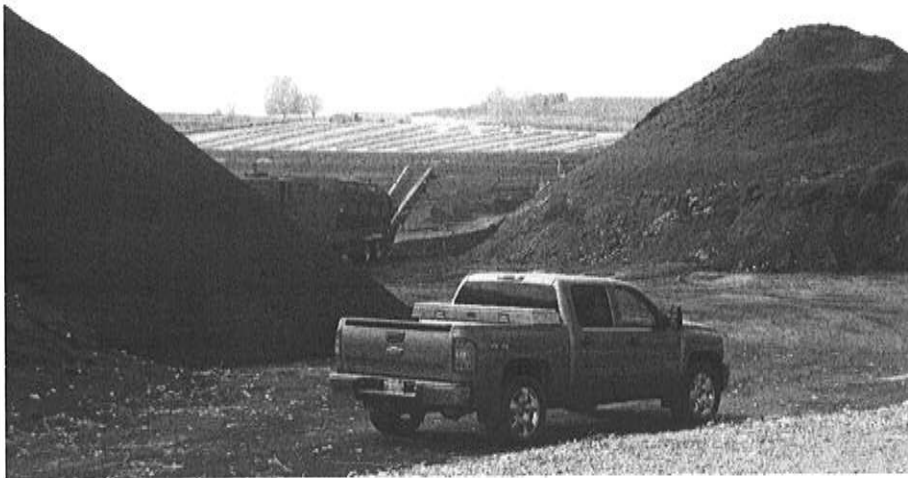
Photo. Cow Palace compost processing area.

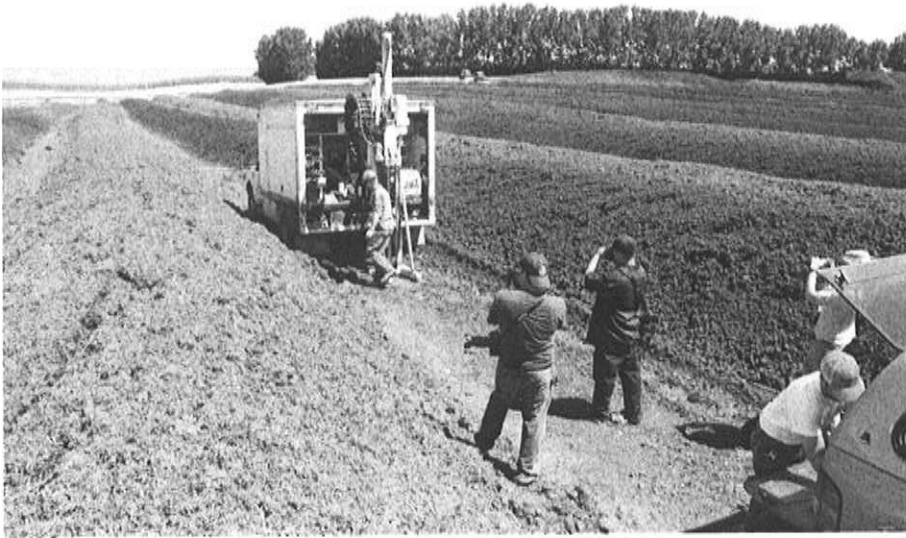
Photo. Soil sample collection in Compost Area.
